PINE RUN DAM, BUCKS COUNTY
PENNSYLVANIA

NDS I.D. NO. PA 00808
DER I.D. NO. 9-170
SCS PA 616

PHASE I INSPECTION REPORT
NATIONAL DAM INSPECTION PROGRAM

WOODWARD-CLYDE CONSULTANTS
5120 Butler Pike
Plymouth Meeting, Pennsylvania 19462

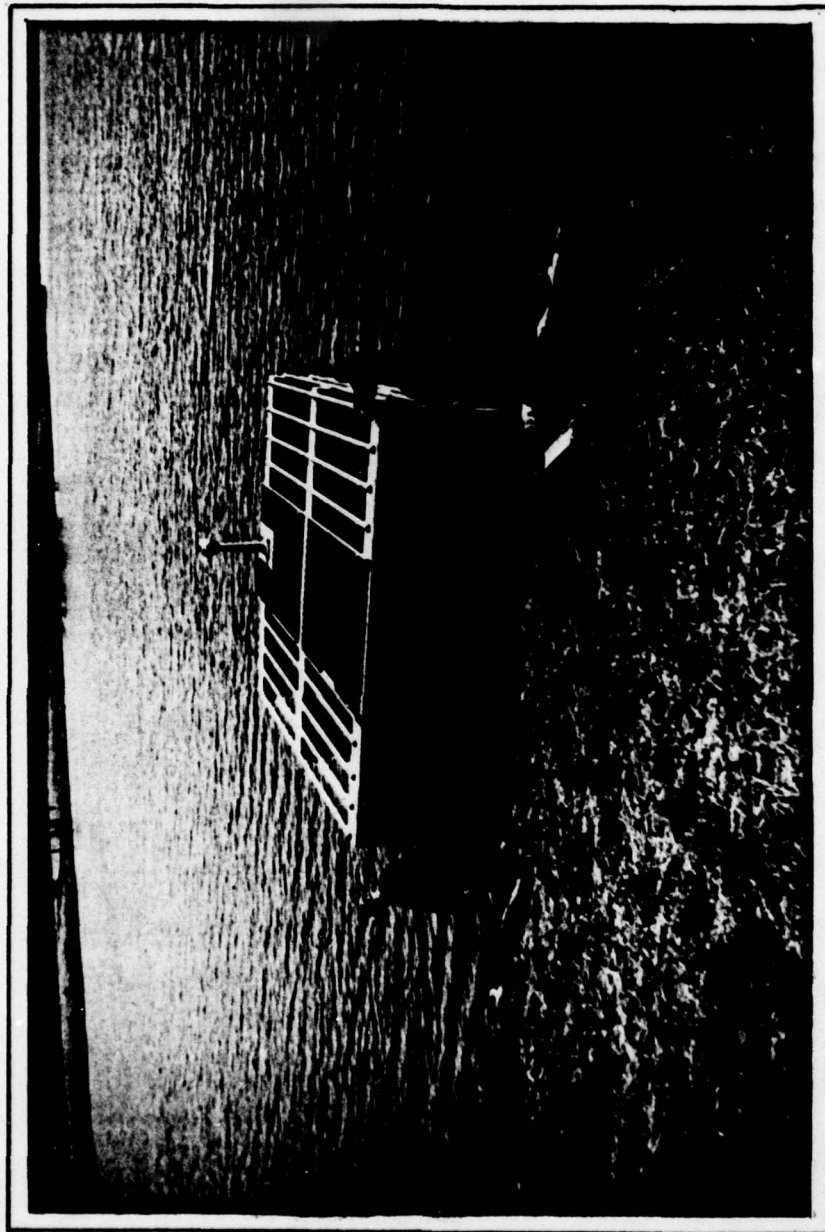
PHOTOGRAPH NO. 1

INTAKE RISER AND POND DRAIN VALVE.

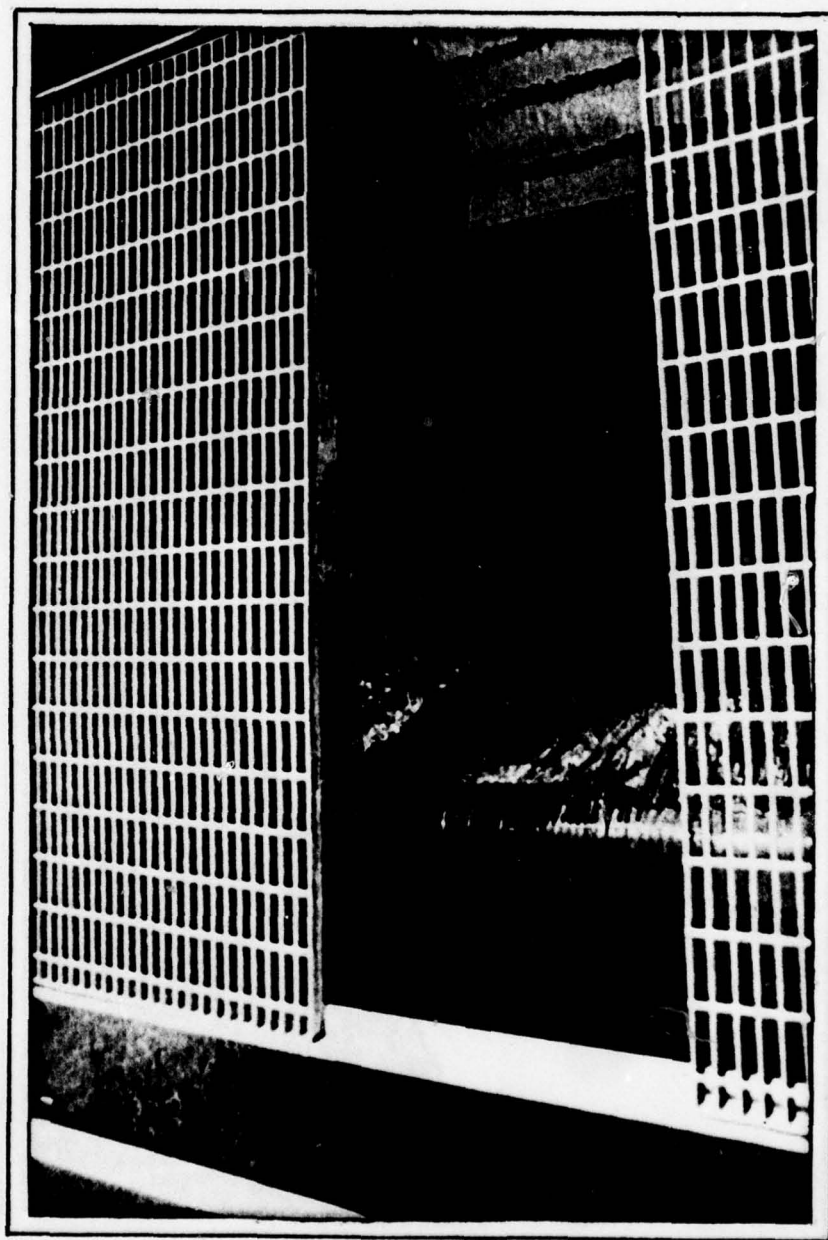
PHOTOGRAPH NO. 2

VIEW OF INTAKE RISER OVERFLOW WEIR.

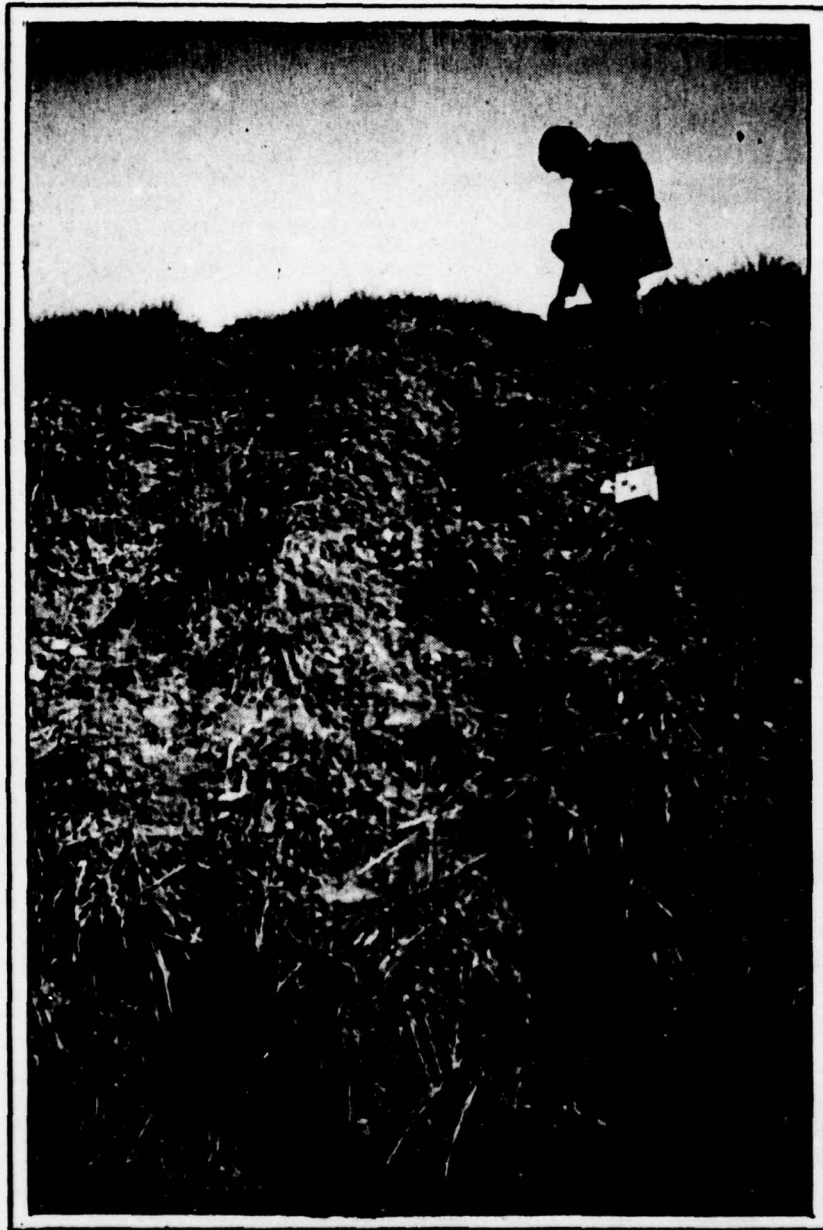
PHOTOGRAPH NO. 12

The embankment crest is also considered to be in poor condition as it contains ruts up to 16 inches in depth with areas of ponded water and mud. The downstream slope also contains patchy areas of vegetation and erosion which can be attributed to trail bike traffic. One gully measured about 14 inches deep; see Photographs 12 and 13.

UPSTREAM EMBANKMENT SLOPE
EROSION AND LACK OF
VEGETATION.

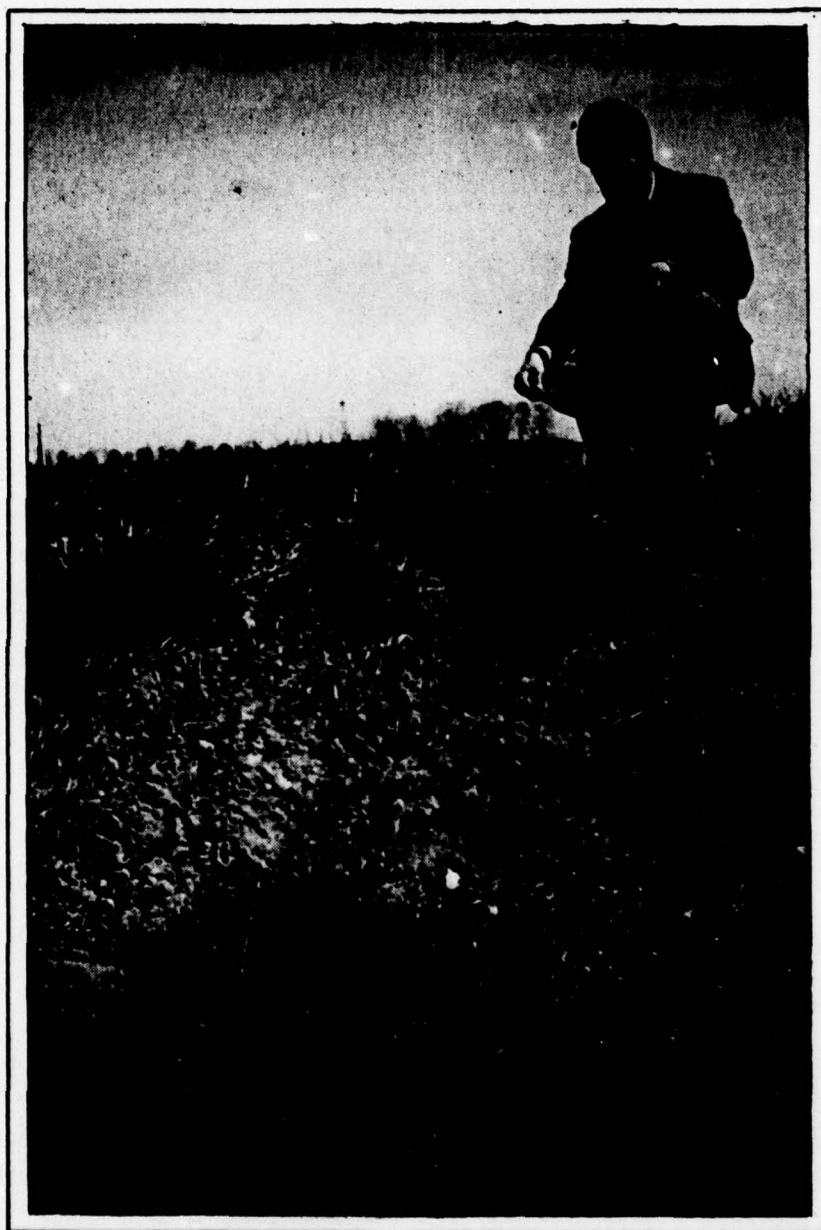
PHOTOGRAPH NO. 13

ALTERNATE VIEW OF GENERAL SLOPE
EROSION IN VICINITY OF PRINCIPAL
SPILLWAY OUTLET STRUCTURE.

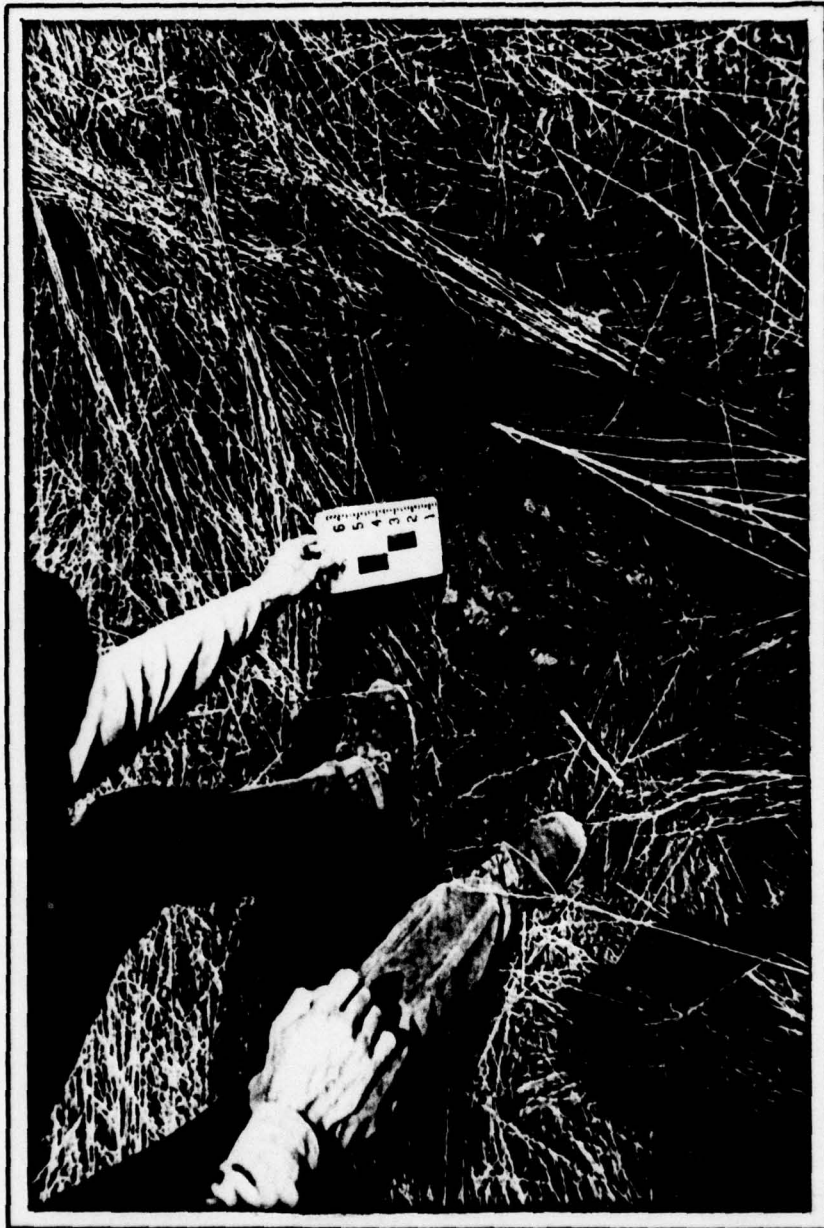
PHOTOGRAPH NO. 14

No signs of seepage were observed at the downstream toe or in areas adjacent to the toe. However, areas of ponded water resulting in wet marshy conditions were noted and assessed to be a result of poor drainage and not of seepage through the embankment or foundation.

None observed but ponded water and soft areas were noted beyond the downstream toe. These areas are attributed to poor grading of the area.

GENERAL MUDDY AND MARSHY CONDITIONS
AT DOWNSTREAM TOE DUE TO STANDING
WATER AS A RESULT OF POOR SURFACE
DRAINAGE.
